UNITED STATES DISTRICT COURT  
EASTERN DISTRICT OF MISSOURI  
EASTERN DIVISION

FRED NEKOUEE, individually,	:	
	:	
Plaintiff,	:	
	:	
vs.	:	Case No. 4:19-cv-0219
	:	
CHPA ENTERPRISES, INC.,	:	
a Missouri corporation,	:	
	:	
Defendant.	:	
	/

**COMPLAINT**  
(Injunctive Relief Demanded)

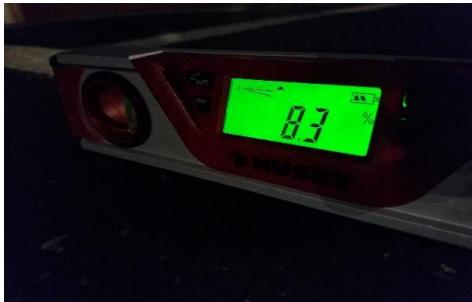
c. (i) In the parking lot, the back section of the parking space (toward the back of a car parked facing toward the Inn) shown in the photograph below has a running slope as

steep as about 1:12 (8.3%) and steeper than a slope of 1:48 (2%). (ii) This running slope is steeper than the maximum allowed slope of 1:48 (2%), in violation of Federal Law 2010, ADAAG § 502.4. (iii) In his wheelchair, the Plaintiff encountered this slope, and it made his wheelchair unstable. (iv) The action required to make this parking space level is easily accomplishable and able to be carried out without much difficulty or expense.

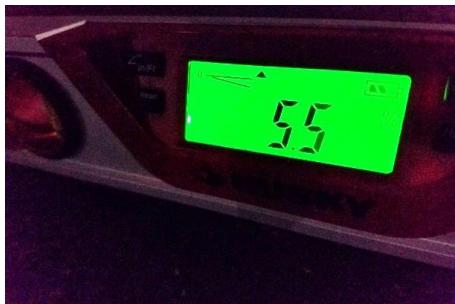
d. (i) In the parking lot, the middle section of the parking space for disabled patrons shown in the photograph below has a running slope as steep as about 1:18.2 (5.5%) and steeper than a slope of 1:48 (2%). (ii) This running slope is steeper than the maximum allowed slope of 1:48 (2%), in violation of Federal Law 2010, ADAAG § 502.4. (iii) While moving in his wheelchair, the Plaintiff encountered this slope and it made his wheelchair unstable. (iv) The action required to make this parking space level is easily accomplishable and able to be carried out without much difficulty or expense.

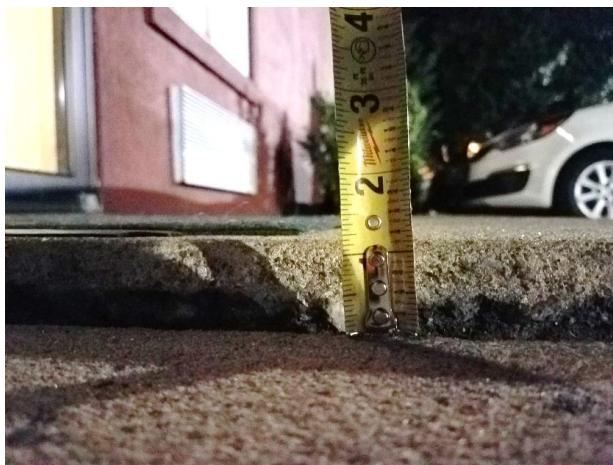
f. (i) The change in level in the sidewalk in front of the entrance door closest to the accessible parking spaces shown in the photographs below is about 1.25 inches and more than a change in level of 0.25 of an inch. (ii) This change of level is greater than 0.25 of an inch, in violation of Federal Law 2010, ADAAG §§ 502.4 and 303.2. (iii) While moving in his wheelchair, the Plaintiff encountered this change in level and it stopped the forward movement of his wheelchair and it made his wheelchair unstable. (iv) The action required to make this sidewalk level is easily accomplishable and able to be carried out without much difficulty or expense.

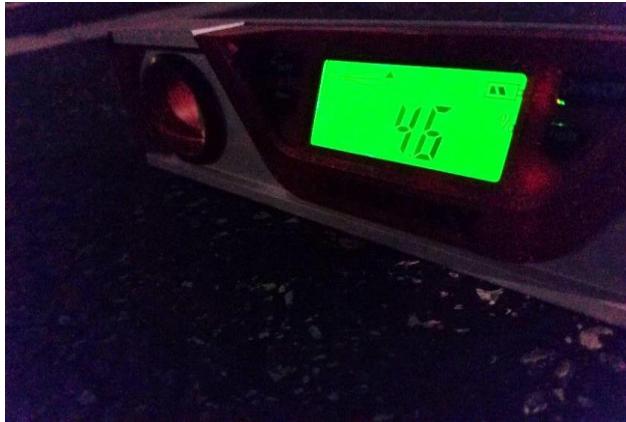
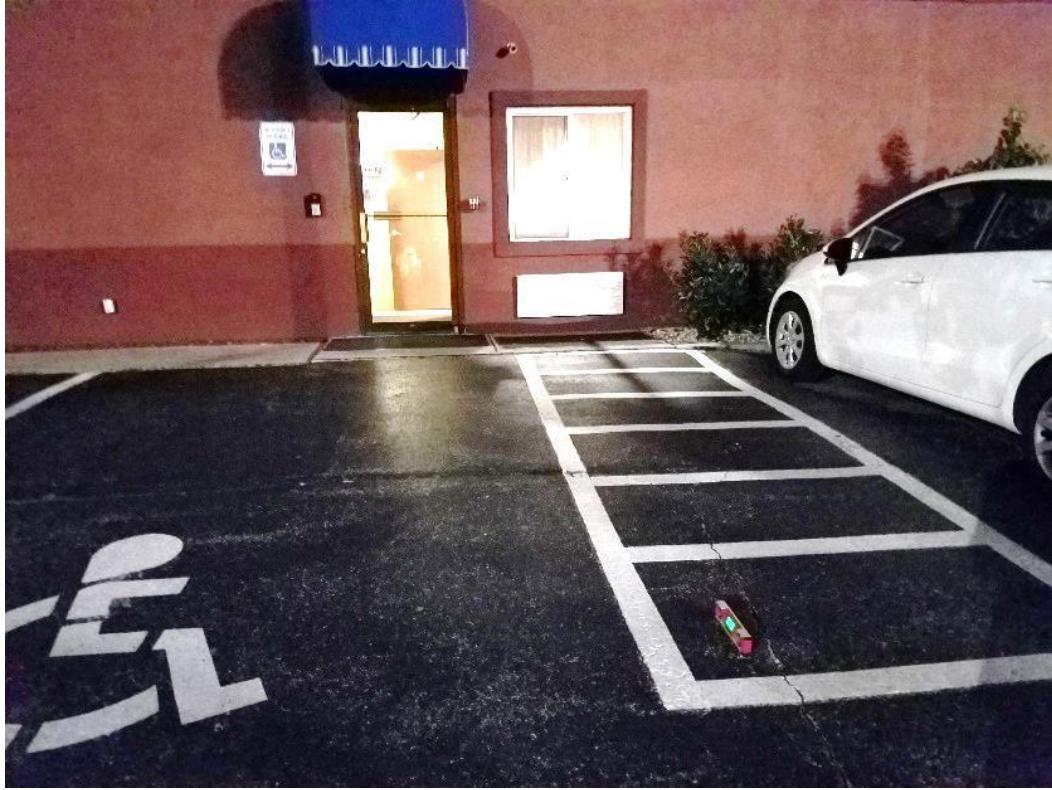
g. (i) In the parking lot, the running slope of the back section of the access aisle (oriented furthest from the building) shown in the photographs below serving the parking spaces for disabled patrons is as steep as about 1:21.7 (4.6%) and steeper than a slope of 1:48 (2%). (ii) This running slope in this access aisle is steeper than the maximum allowed slope of 1:48 (2%), in violation of Federal Law 2010, ADAAG § 502.4. (iii) While moving in his wheelchair, the Plaintiff encountered this slope in this access aisle, and it made his wheelchair unstable, and he required assistance to ascend this access aisle in his wheelchair. (iv) The action required to make this access aisle level is easily accomplishable and able to be carried out without much difficulty or expense.

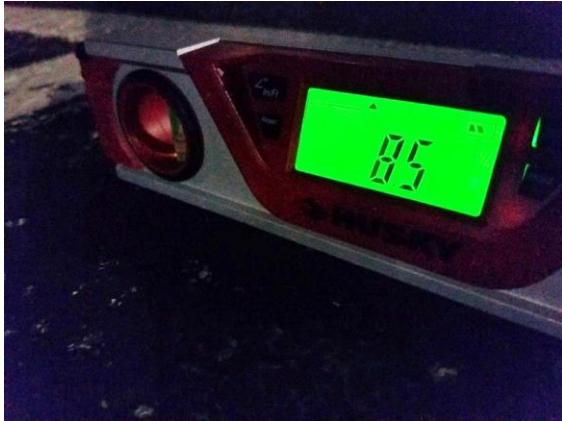
h. (i) In the parking lot, the running slope of the back section of the access aisle (oriented furthest from the building) shown in the photographs below serving the parking spaces for disabled patrons is as steep as about 1:11.8 (8.5%) and steeper than a slope of 1:48 (2%). (ii) This running slope in this access aisle is steeper than the maximum allowed slope of 1:48 (2%), in violation of Federal Law 2010, ADAAG § 502.4. (iii)

While moving in his wheelchair, the Plaintiff encountered this slope in this access aisle, and it made his wheelchair unstable, and he required assistance to ascend this access aisle in his wheelchair. (iv) The action required to make this access aisle level is easily accomplishable and able to be carried out without much difficulty or expense.

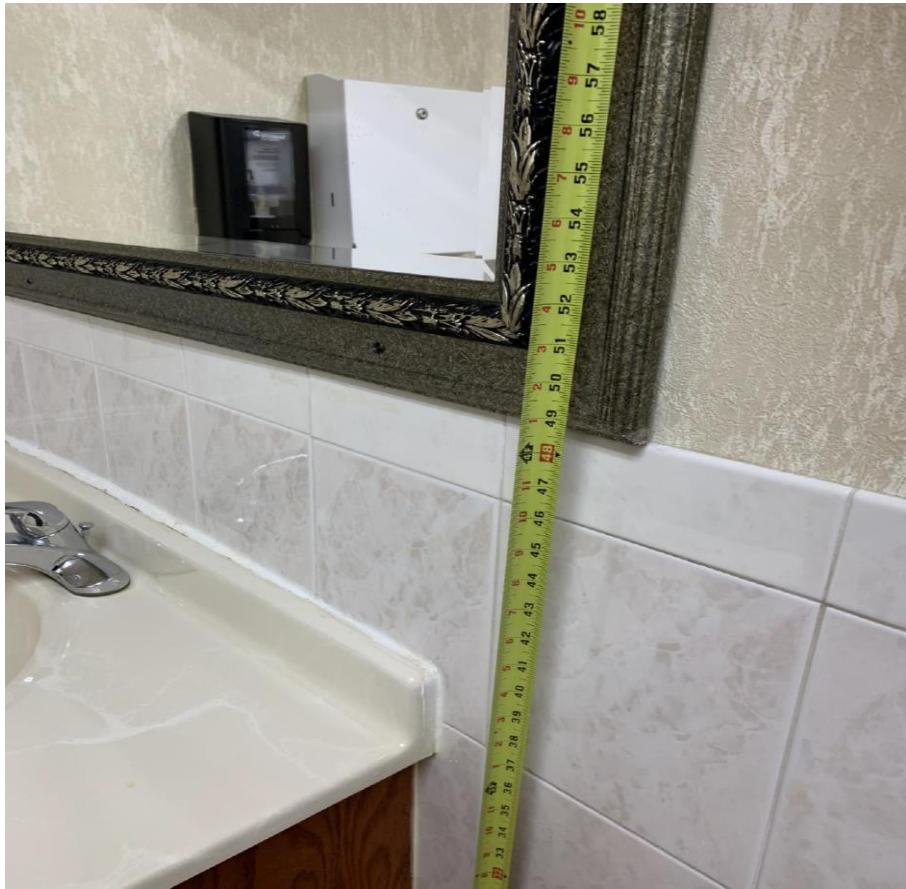
n. (i) In the men's restroom in the lobby, the bottom edge of the mirror's reflecting surface is about 52 inches above the floor and higher than 40 inches above the floor. (ii)

As shown in the photograph below, the bottom edge of this mirror's reflecting surface is higher than 40 inches above the finish floor, in violation of Federal Law 2010, ADAAG § 603.3. (iii) from his wheelchair, the Plaintiff could not see his full face in this mirror. (iv) The action required to relocate this mirror's reflecting surface is easily accomplishable and able to be carried out without much difficulty or expense.

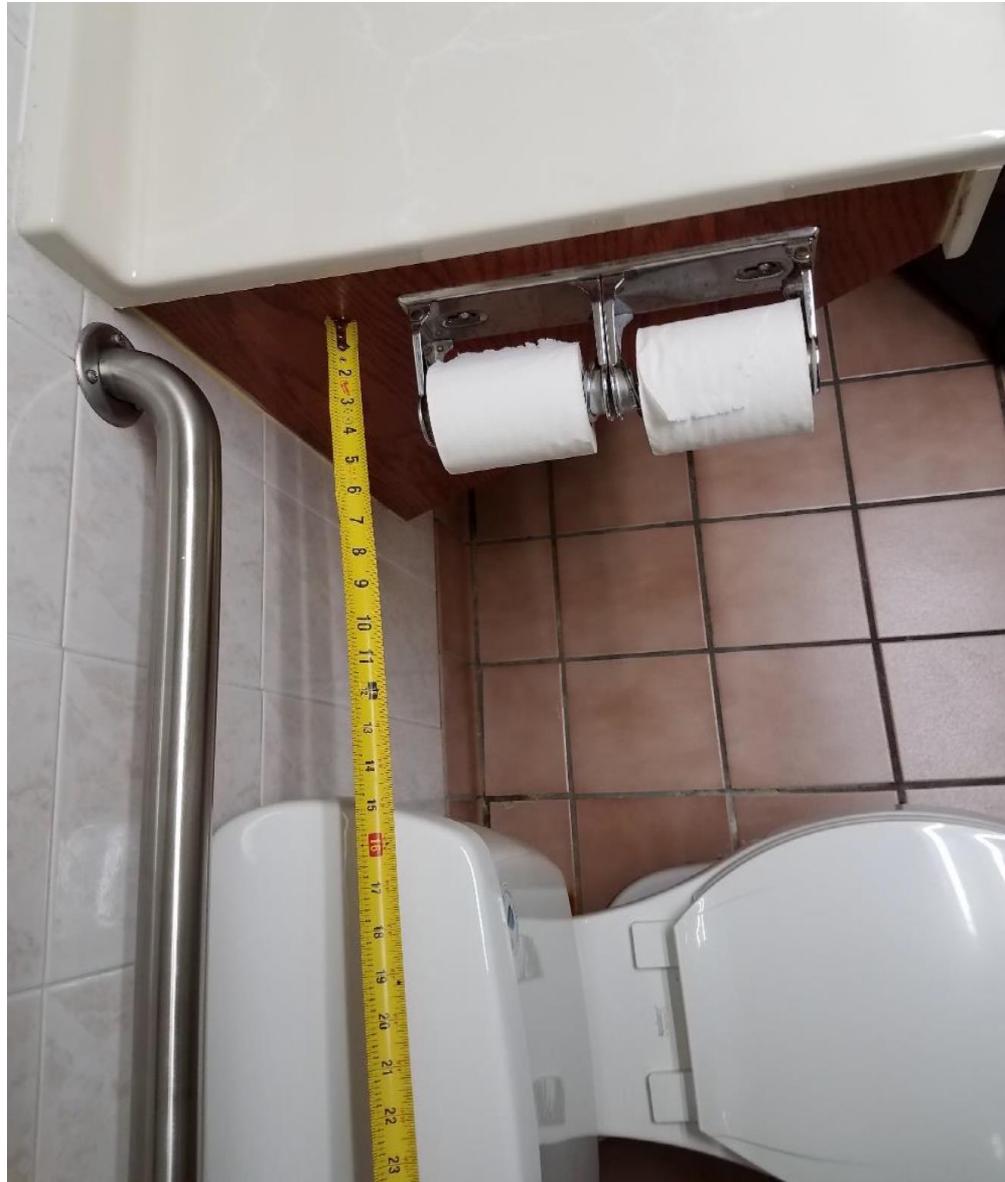
w. (i) In the women's restroom in the lobby, the centerline of the toilet paper dispenser is not between 7 and 9 inches from the front of the water closet or toilet. (ii) As shown in the photograph below, the centerline of this toilet paper dispenser is not located between a minimum of 7 inches and a maximum of 9 inches from the front of the water closet, in violation of Federal Law 2010, ADAAG § 604.7. (iii) The Plaintiff observed this condition, and it deters him from visiting America's Best Value Inn & Suites. (iv) The action required to relocate or replace this toilet paper dispenser is easily accomplishable and able to be carried out without much difficulty or expense.

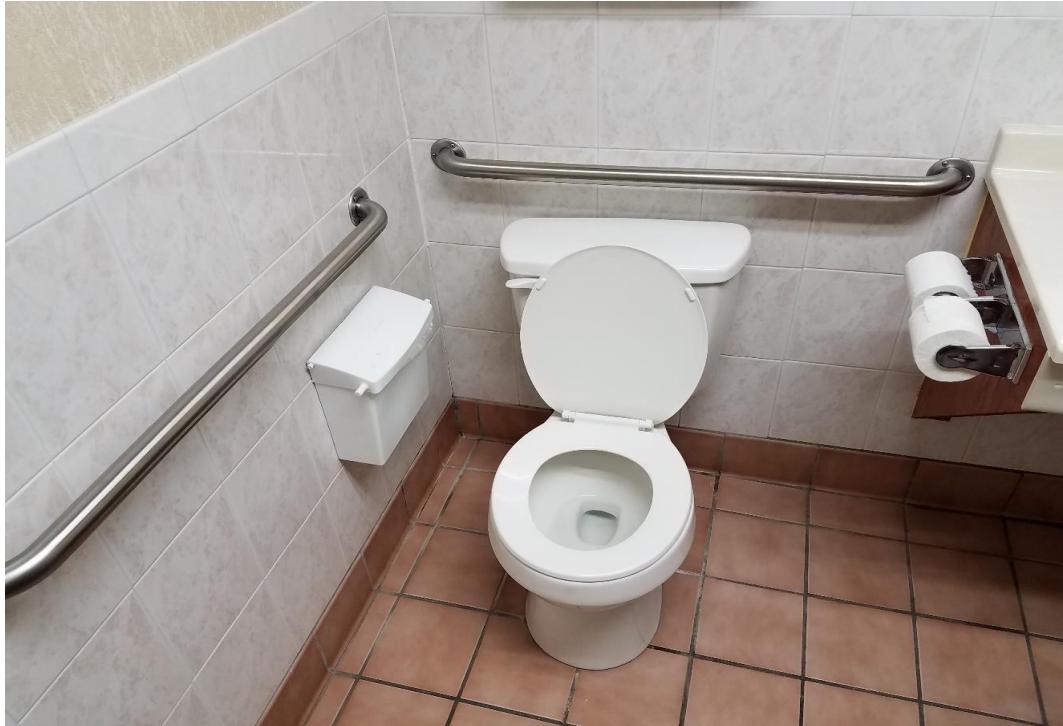
aa. (i) In the women's restroom in the lobby, the toilet in the accessible toilet compartment does not have the flush control mounted on the open and wide side of the clear floor space. (ii) As shown in the photograph below, the flush control for this toilet is not mounted on the open and wide side of the clear floor space, in violation of Federal Law 2010, ADAAG § 604.6. (iii) The Plaintiff observed this condition, and it deters him from visiting America's Best Value Inn & Suites as it would be very difficult to flush the toilet from his wheelchair. (iv) The action required to install a flush control on this toilet on the open and wide side of the clear floor space is easily accomplishable and able

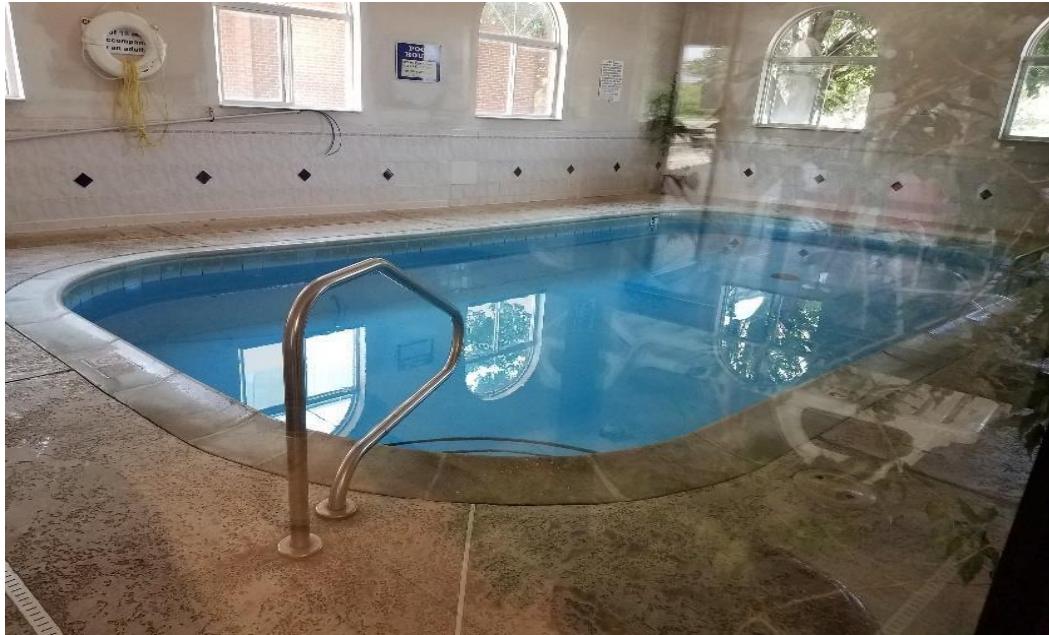
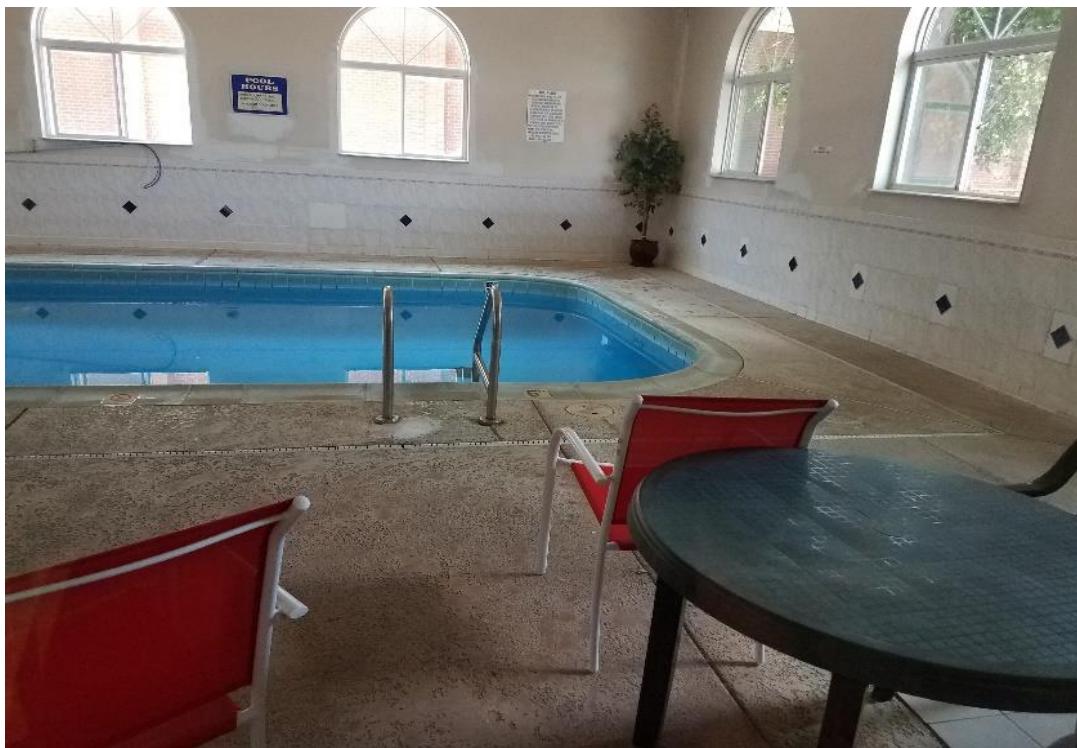
ss. (i) The swimming pool does not have an accessible means of entry and does not have a lift or sloped entry. (ii) This pool, which has less than 300 linear feet of swimming pool wall, does not have an accessible means of entry, a swimming pool lift or sloped entry as shown in the photographs below, in violation of Federal Law 2010, ADAAG §§ 242.2, 1009.2, 1009.3. (iii) Due to the lack of an accessible means of entry, the Plaintiff could not enter the pool. (iv) The action required to install a lift in this pool is easily accomplishable and able to be carried out without much difficulty or expense.
